A Landfill Botanic Garden

Armand Sarinana

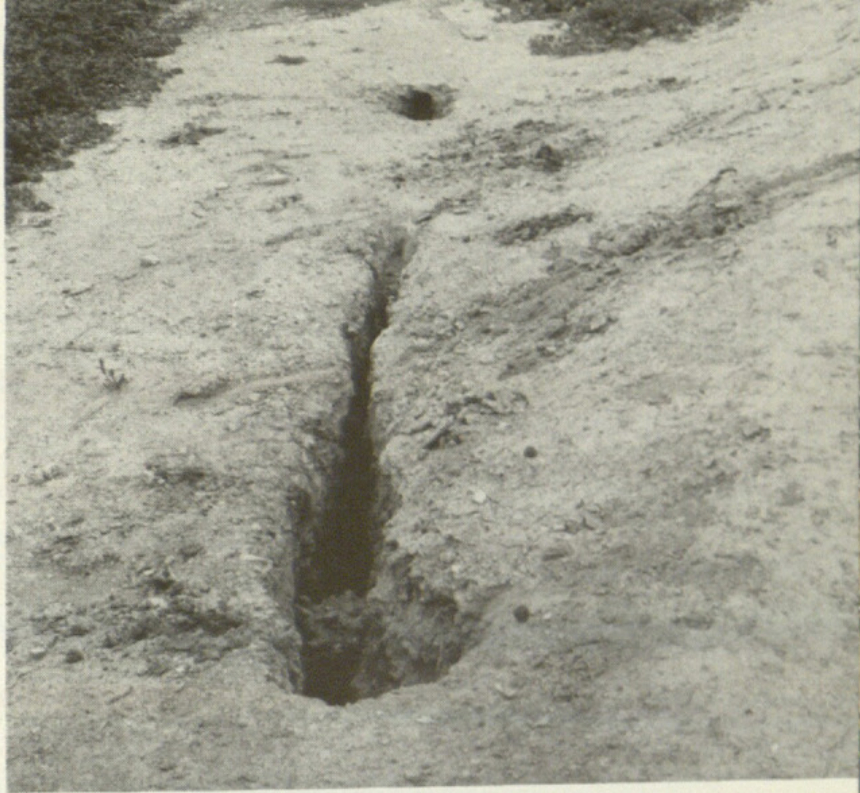
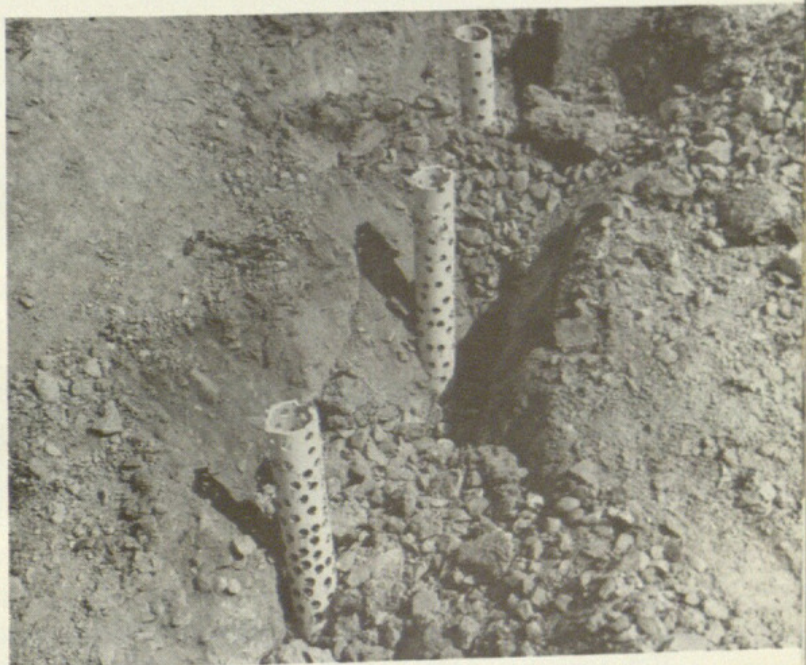
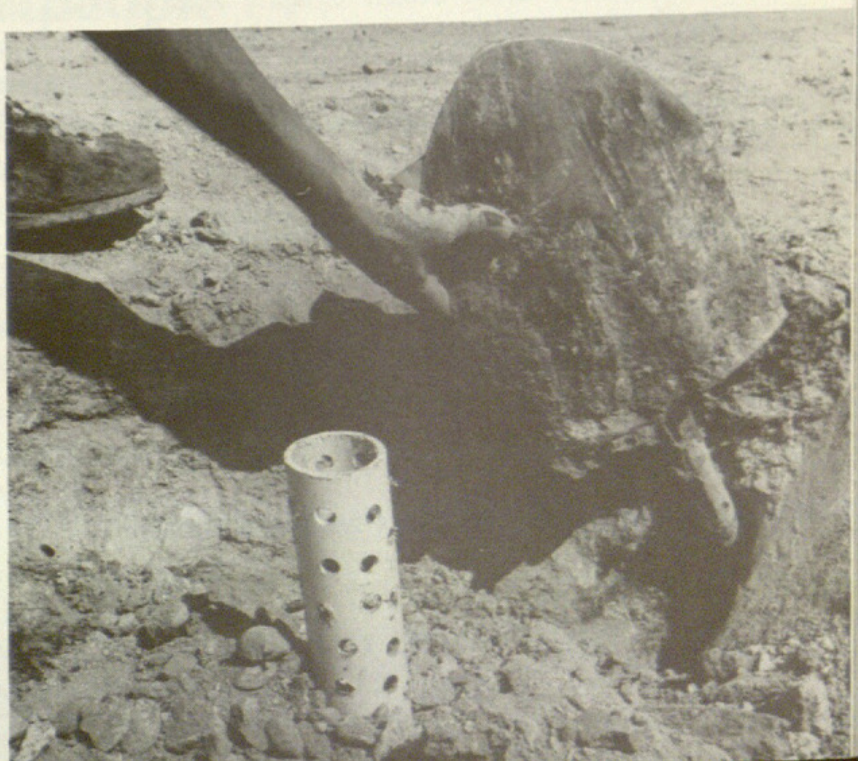
These pictures show a large fissure at South Coast Botanic Garden and typical filling and venting. Top photo shows the fissure that developed from the pressure of escaping gas. Note that there is no plant life in the immediate vicinity. Second photo shows the fissure filled in and vented by plastic, perforated pipe. Third photo is simply a close-up view with a long-handled shovel thrust into the hole to indicate the depth of the fissure.

In the localized zones of greatest gas heat, and pressure activity, fissures serve as escape vents. Several main fissures transverse the garden and since soil temperatures are the highest at these escape vents all plant growth is impossible. These areas are therefore designated as study points of trash decomposition for the visitor. Differences in solid and fill land can also cause fissures, especially where great weight is involved. An example is the fissure that developed adjacent to the 1.75-acre artificial lake. The imbalance of the land in this particular area, coupled with a severe earthquake that occurred in February of 1971, caused the fissure, which in turn caused the asphalt-jute waterproofing membrane on the bottom of the lake to rupture. The ensuing geological study by the County Engineers and Sanitation District resulted in the recommendation that the lake perimeter be reduced, thereby bringing in the lake margins over non-trash filled areas and away from the fissure zone.

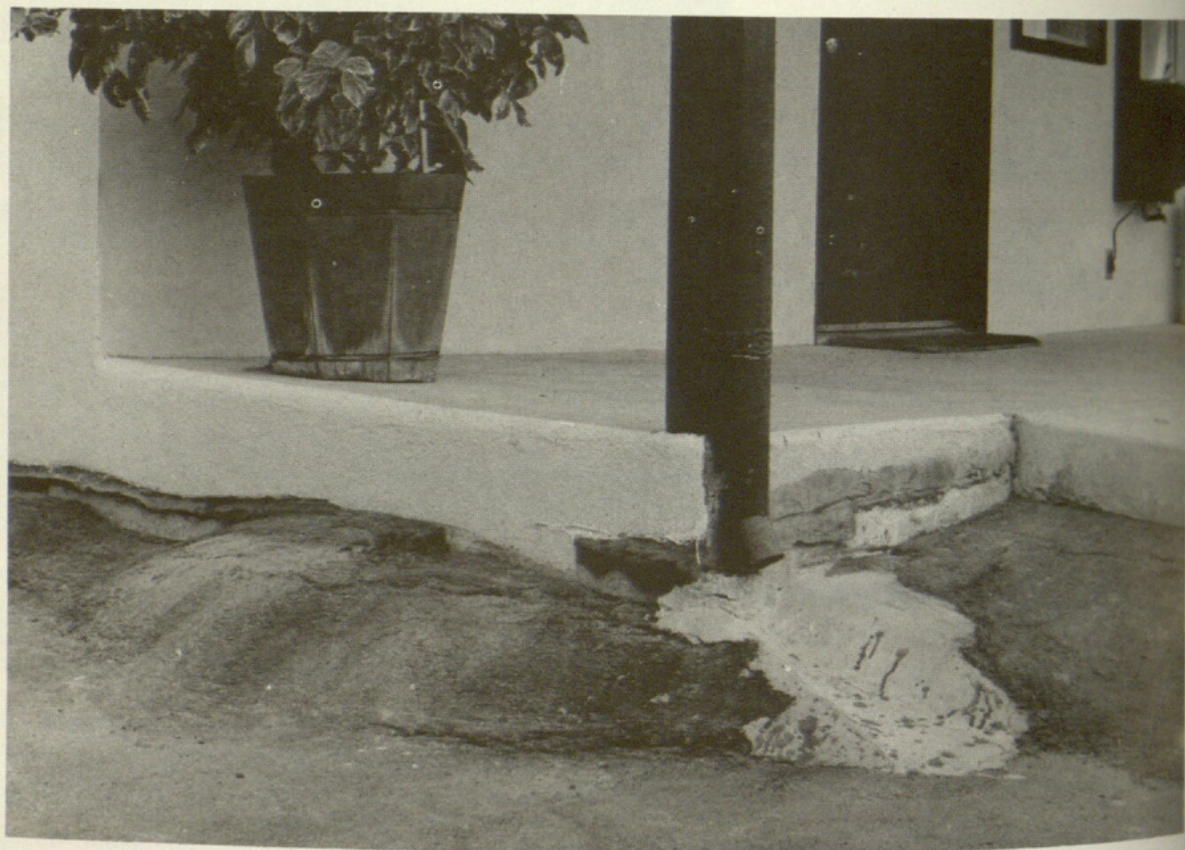
This photo shows the sinking of the land around the foundation of the current administration office. Because it was set on pilings, the office floor remained stable.

Because of the subsidence factor, all permanent building construction is forbidden unless built on pilings driven to the bedrock area. South Coast's current building and shop area were constructed on 40-foot pilings. This construction was generally effective insofar as the structures are concerned, but as can be seen in the picture, the land bordering the structures shows the results of more or less continuous subsidence. The new office-auditorium complex presently under construction will be located on the only solid one-acre area in the garden site.
